Western Winds HOA

Tucson, AZ

Report #: 42614-0

RESERVE STUDY
"Full"

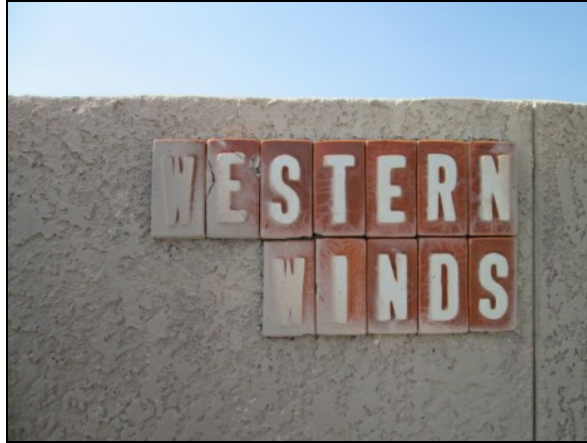
Comments: Monument signs consist of tiled letters stating, "WESTERN WINDS" mounted to entry stucco walls. Appear to be older and dated with wear evident. We assume this is not a priority as this time. This component funds an allowance to update/refurbish the monument signs.

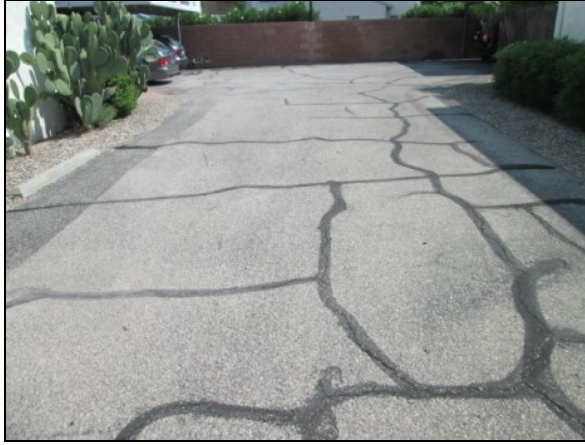
Comments: Appears to be older and worn with significant cracking. Life span is based on periodically seal coating and maintaining the surface. This component funds to completely remove and repave the asphalt.

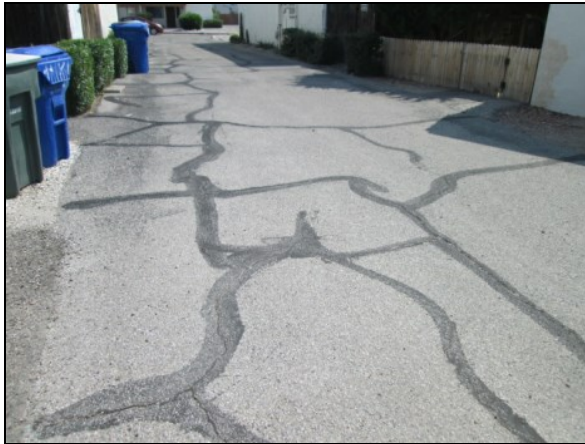
Comp #: 202 Asphalt - Seal/Repair**Quantity: Approx 30,000 Sq Ft**

Comments: No seal coat evident. Periodic seal coating has been scheduled to occur after the asphalt repave project. Seal coat asphalt surfaces periodically to prevent premature cracking and deterioration.

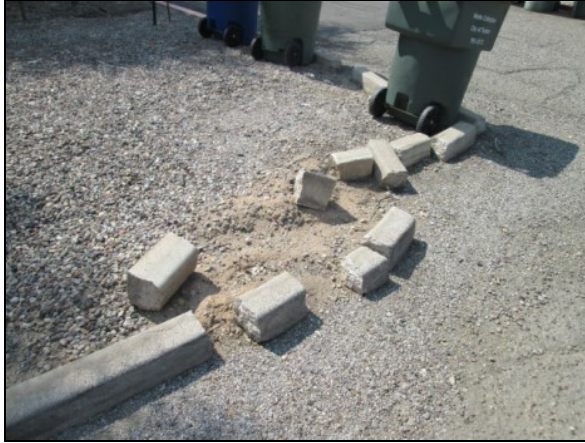
Comp #: 220 Concrete - Repair**Quantity: Numerous Sq Ft**

Comments: There is no expectancy to completely replace the concrete. This component funds an allowance for periodic repairs and partial replacements as needed. Several areas of curbing were observed to be damaged.

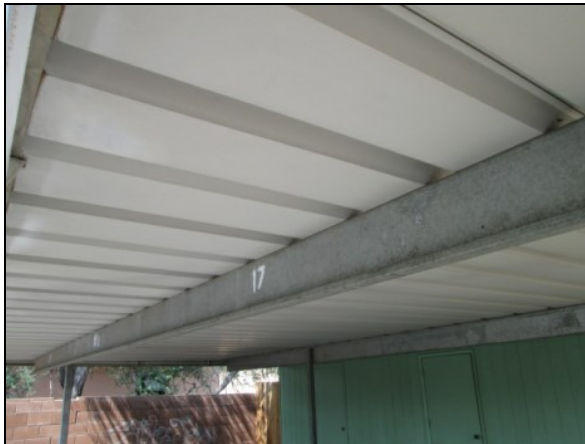
Comp #: 280 Carport Roofs - Repair/Replace**Quantity: Numerous Sq Ft**

Funded?: No. Repairs and replacement of the carport roofs is reportedly each owner's responsibility, not the HOA.

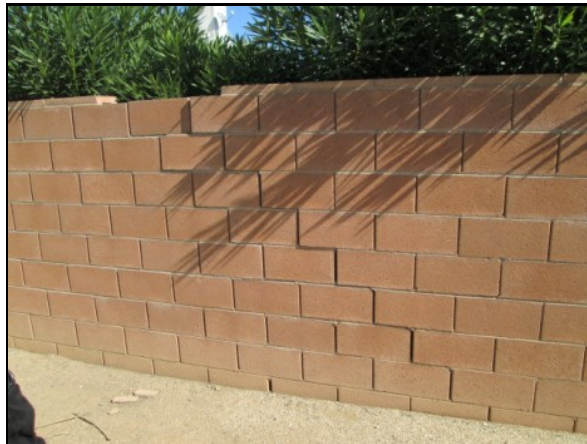
Comp #: 500 Block/Stucco Walls - Repair

Comments: Walls are expected to last the life of the community under normal circumstances. This component funds an allowance for repairs and partial replacement due to excessive settling or other sources of damage. Cracking and settling evident throughout.

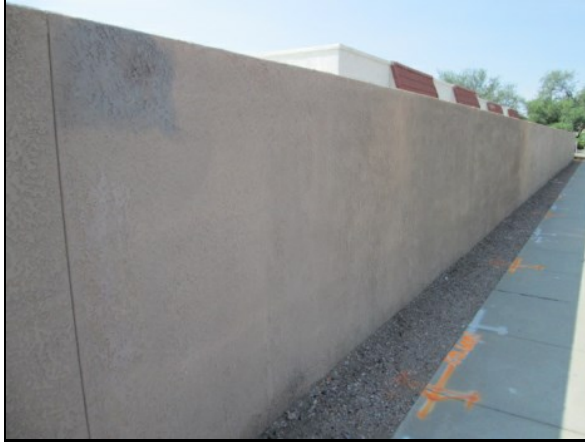
Comments: Observed to be discolored and non-uniform. This component funds to periodically repaint the entry stucco walls.

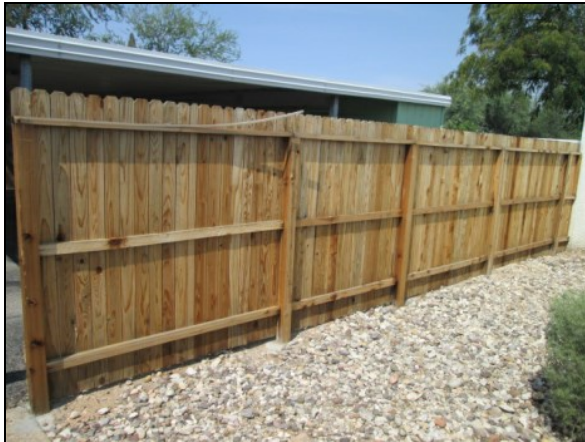
Comp #: 510 Wood Fence - Replace**Quantity: Approx 60 LF**

Comments: Observed to be new, intact, secure and in good shape. Future replacement should be anticipated.

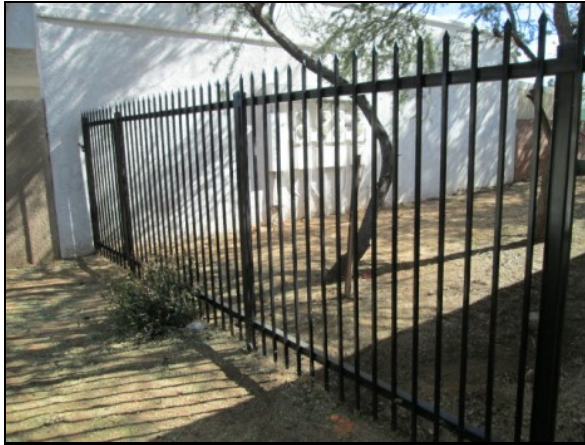
Comp #: 515 Metal Fence - Replace

Comments: Observed to be new, intact, secure and in good shape. Future replacement should be anticipated.

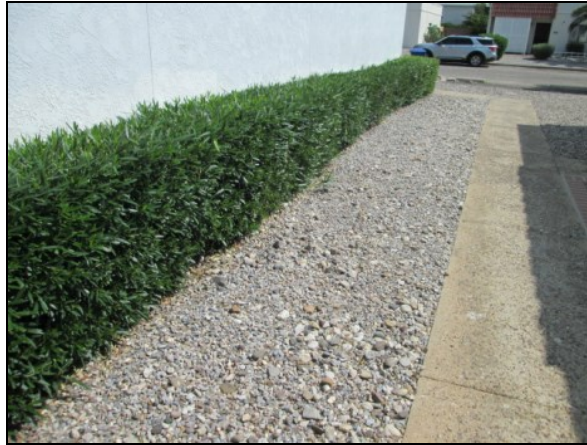
Comp #: 600 Irrigation System - Replace

Funded?: No. It is beyond the scope of this Reserve Study to quantify and assess conditions of the irrigation system. Funding can be added for future replacement at the client's request, but we need to be provided with cost and life expectancy estimates.

Repairs and partial replacements should be included in the annual landscape maintenance budget.

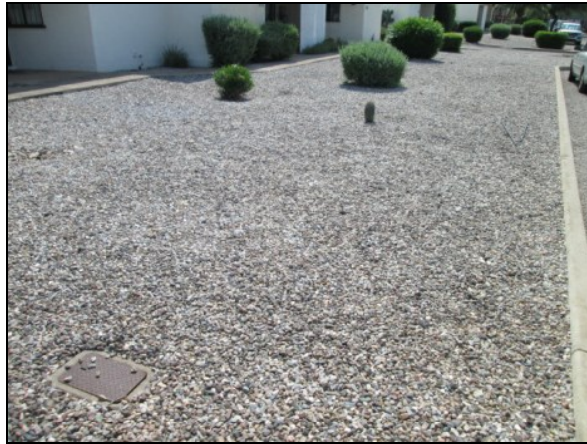
Comments: Common areas are covered in small river rock throughout. Complete replacement is not anticipated. Coverage will deplete over time, so this component funds an allowance to replenish a portion of the rock.

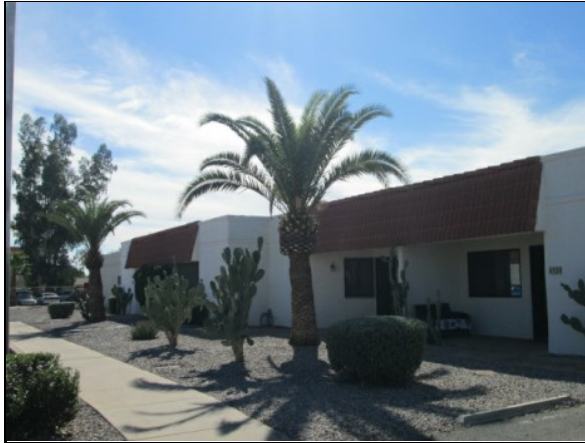
Comp #: 650 Trees - Remove/Replace (Ongoing)**Quantity: Numerous Trees**

Comments: This component funds an allowance to remove or replace trees throughout the community.
